Classification and Mechanical Properties

MAXALLOY® 5A

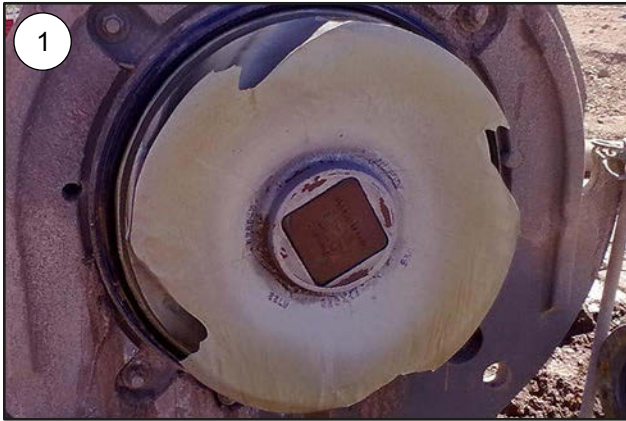
Standard hard iron impeller after 40 service days

Photo 1 shows the standard hard iron impeller after only 40 service days. Substantial wear can be seen on the impeller edge and vanes.

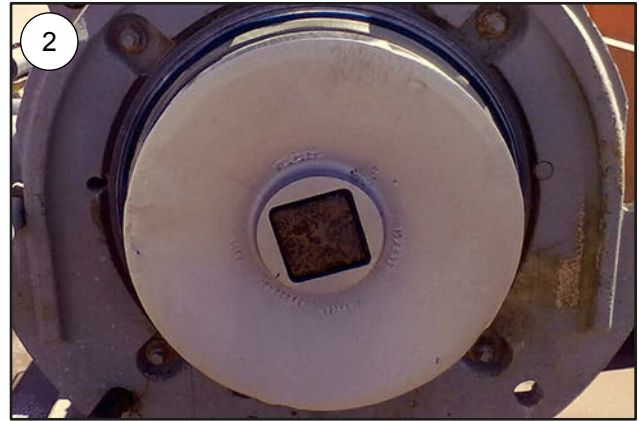
MAXALLOY® 5A impeller after 97 service days

Photo 2 shows the new MAXALLOY® 5A impeller after 97 service days. The pump was reassembled and the impeller ran successfully for 135 service days, over 3 times longer than standard hard iron.

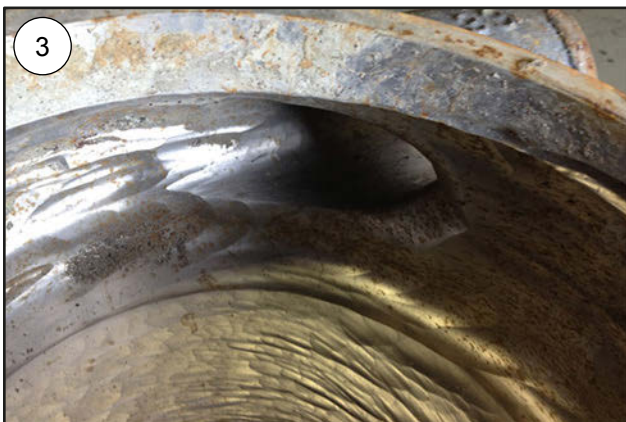
Standard hard iron case after 5 service days

Photo 3 shows the standard hard iron case after only 5 service days. Deep wear trenches are clearly visible in the case walls because of the lower fracture toughness and hardness. Significant corrosion can also be seen on the exposed surfaces.

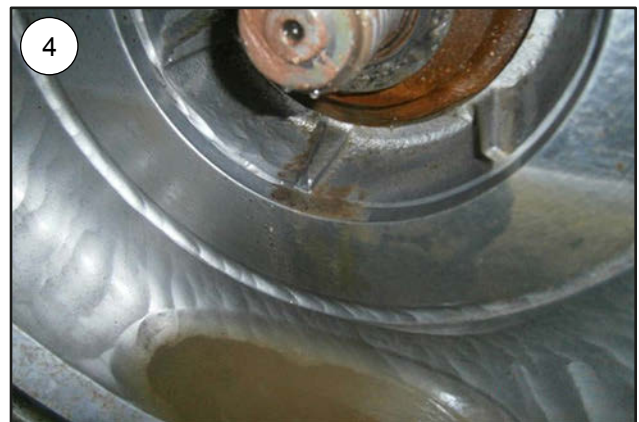
MAXALLOY® 5A case after 21 service days

Photo 4 shows the new MAXALLOY® 5A case after 21 service days. The wear pattern shows plastic deformation instead of wear trenches, indicating high and uniform hardness distribution through the pump case wall. The MAXALLOY® 5A case also shows no signs of corrosion.
